# Roadway Deicing Operations in the City of Fort Collins and Impacts to an Urban Stream

Department of Civil  
and Environmental  
Engineering

*March 10, 2021*

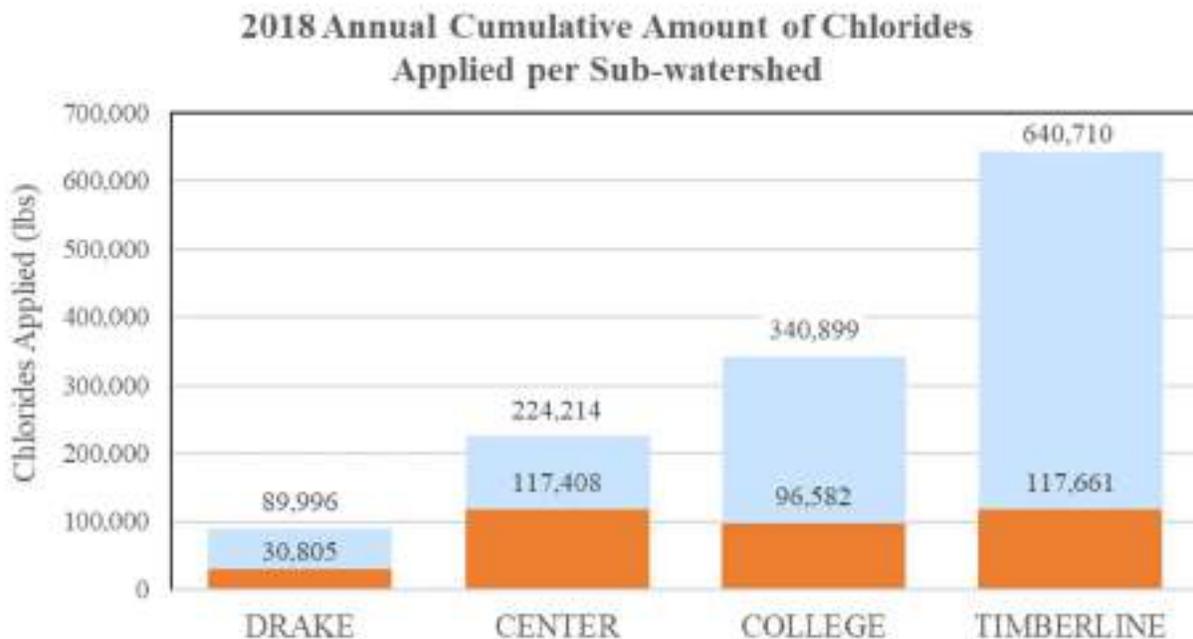
Figure ES.1 shows the amount of chloride that was applied during snow events from November 2017 until April 2018. Also displayed in the figure is the amount of chloride that was actually delivered to each of the monitoring stations located at each subwatershed outfall. It is evident from the figure that only a fraction of the deicer applied within each subwatershed was delivered to Spring Creek, begging the question, what is happening to the chloride?

**Figure ES.1:** Chlorides applied for RDO compared to the amount of chlorides measured at each monitoring location

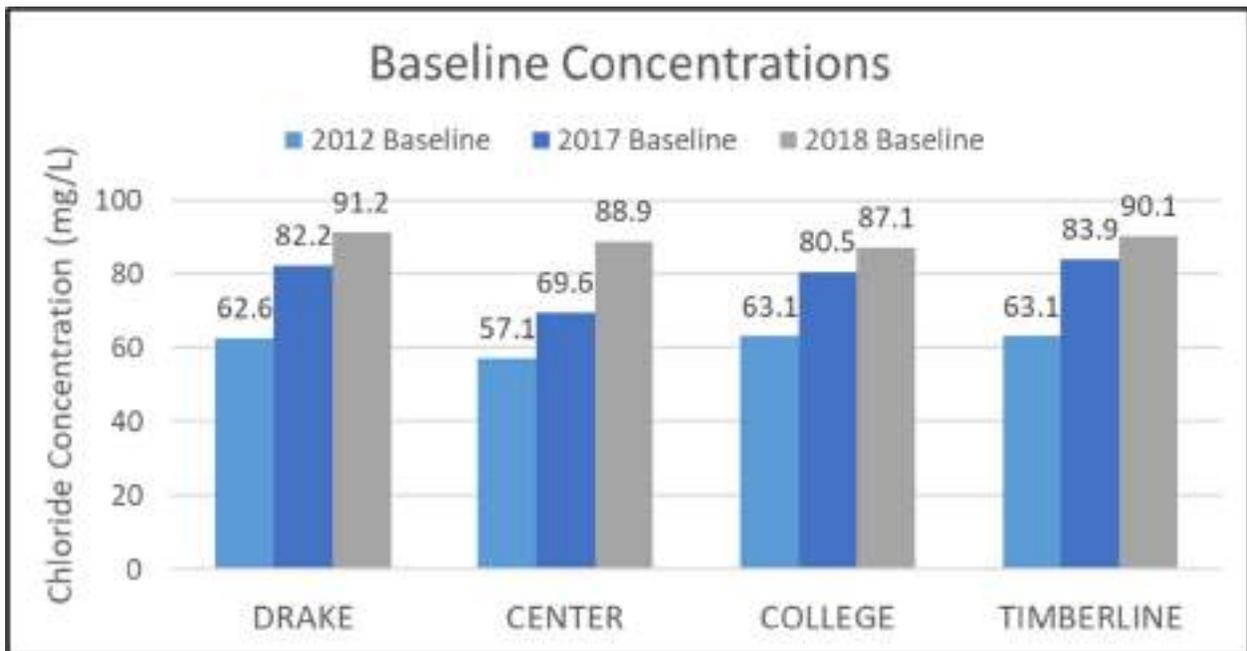
Figure ES.2 shows the measured baseline chloride concentrations. Baseline concentrations were determined by considering the most commonly occurring concentration at each stream monitoring station once all winter runoff had been received and flows returned to normal levels. Assuming baseline chloride concentrations continue to rise at the observed rate, it would take the Drake, Center, College, and Timberline subwatersheds 13.3 years, 5.3 years, 6.7 years, and 22.2 years to reach the chronic toxicity level of 230 mg/L, a level set by the Colorado Department of Public Health and Environment for water to be used as a drinking water source.

**Figure ES.2:** Baseline Concentrations at each monitoring location based on the 2012, 2017 and 2018 winters

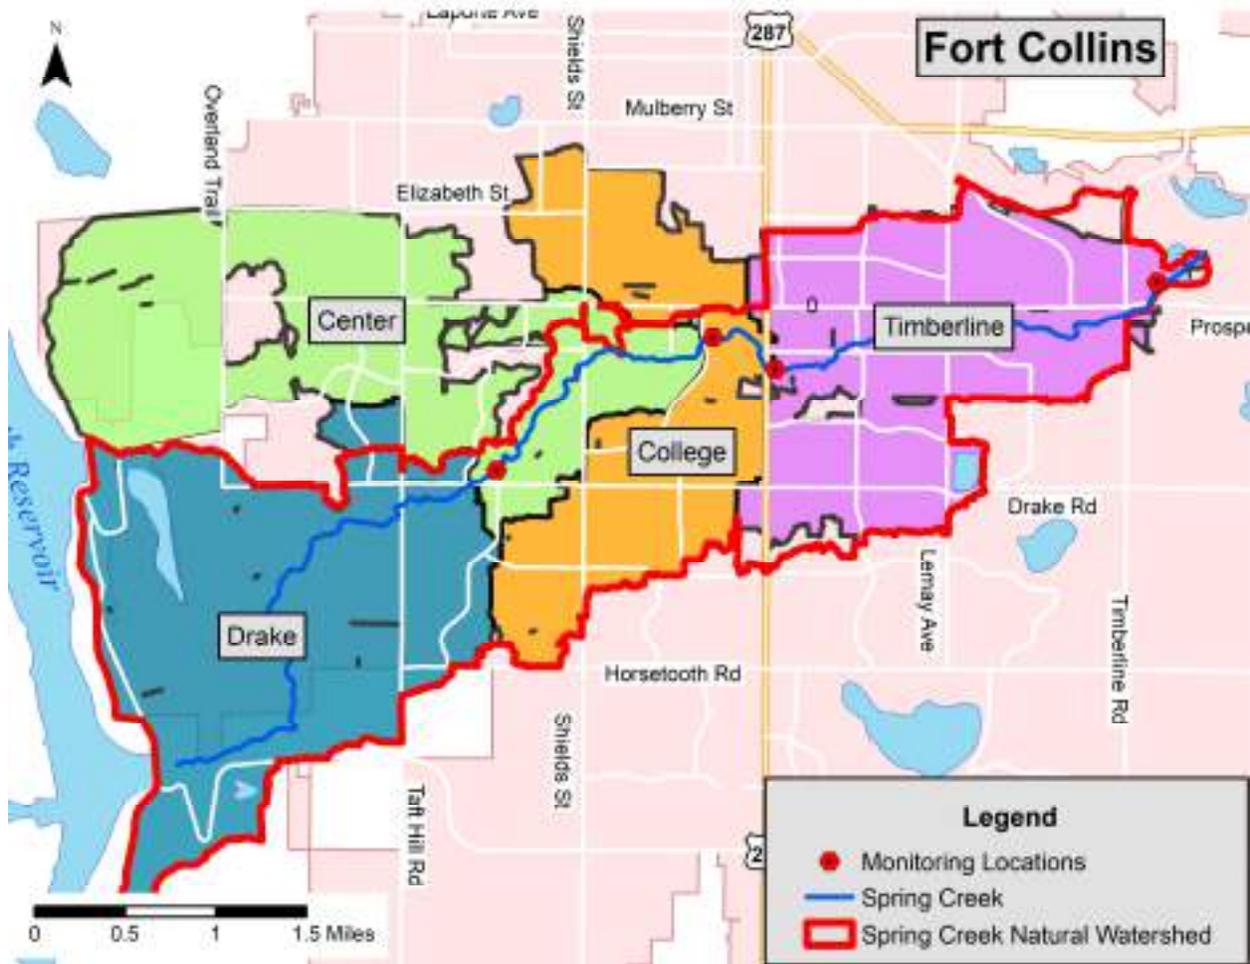
**Figure 1:** Spring Creek subwatersheds and monitoring site locations at Drake Road, Center Avenue, College Avenue and Timberline Road.

The Drake subwatershed serves primarily low-density development and open space. The Center subwatershed serves primarily residential units. The College subwatershed contains the highest density land use and receives runoff from U.S. Highway 287/College Avenue. Finally, the Timberline subwatershed also serves low density development and open space similar to the Drake subwatershed. For each watershed the amount of chloride deicers applied as a part of roadway deicing operations (RDO) was tracked as well as the amount of chloride found at each monitoring location along Spring Creek. Figure 1 provides locational information for each subwatershed and stream monitoring location.

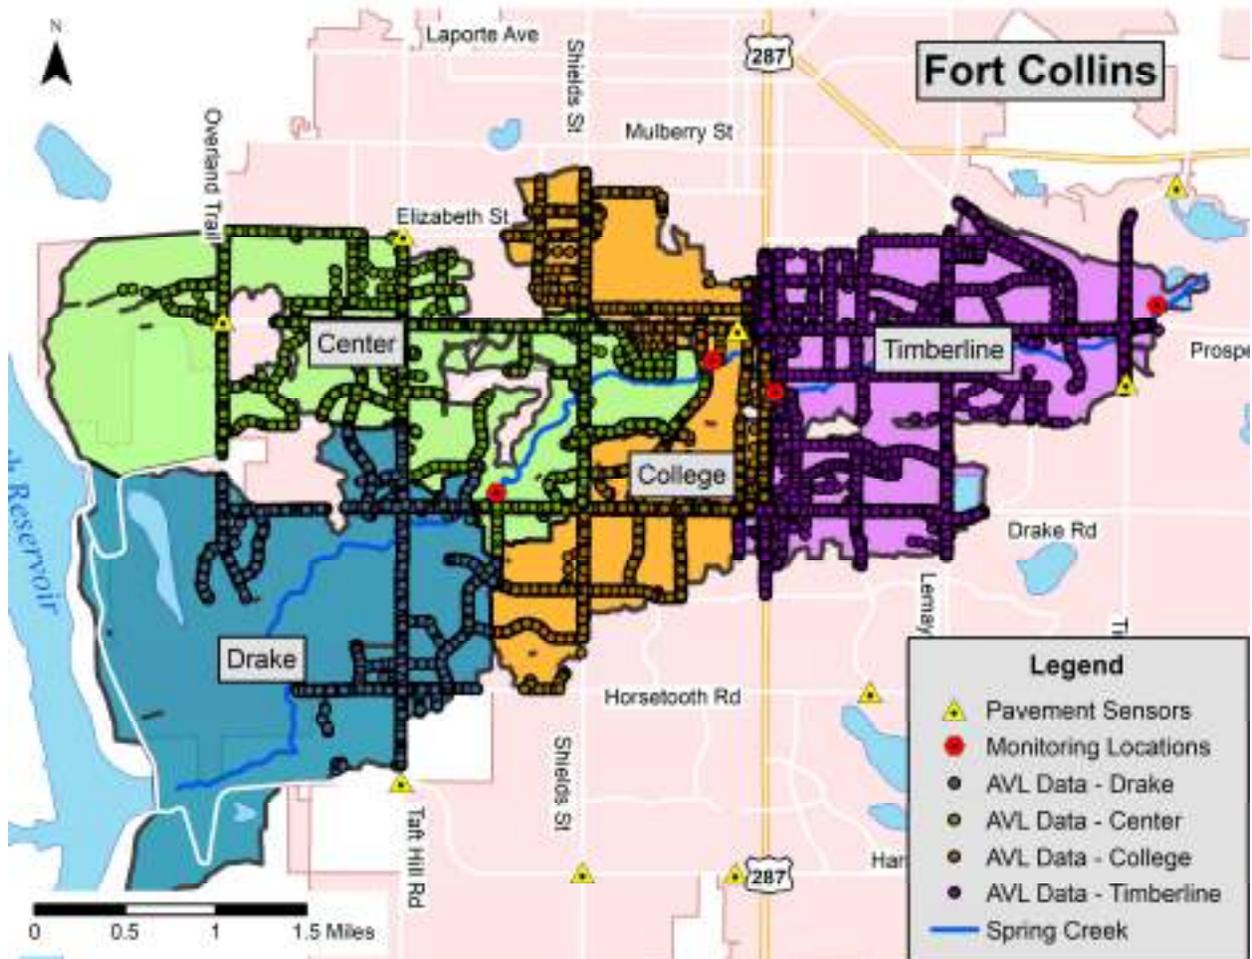
**Figure 2:** Total amount of deicing agents that were applied to roadways within the Spring Creek watershed. Also displayed in this image are the locations of the pavement sensors which monitor pavement performance.

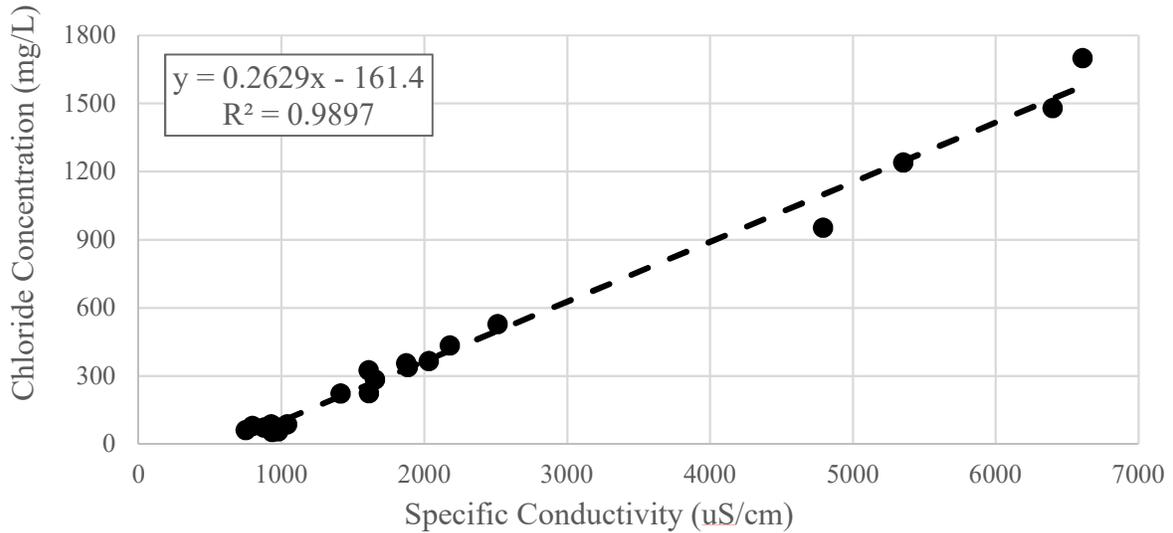
The SpC and chloride concentrations were then plotted and a linear regression was used to represent the relationship between SpC and chloride concentrations. The regression contained an  $R^2$  value of 0.99, demonstrating a very strong relationship. Figure 3 shows the relationship between specific conductivity and chloride concentration as well as the equation used to correlate specific conductivity to chloride concentrations. From this relationship a timeseries of chloride concentrations was used to determine both the chloride load delivered to the stream and potential environmental consequences of RDO.

**Figure 3:** Plot demonstrating the relationship between specific conductivity and chloride concentrations

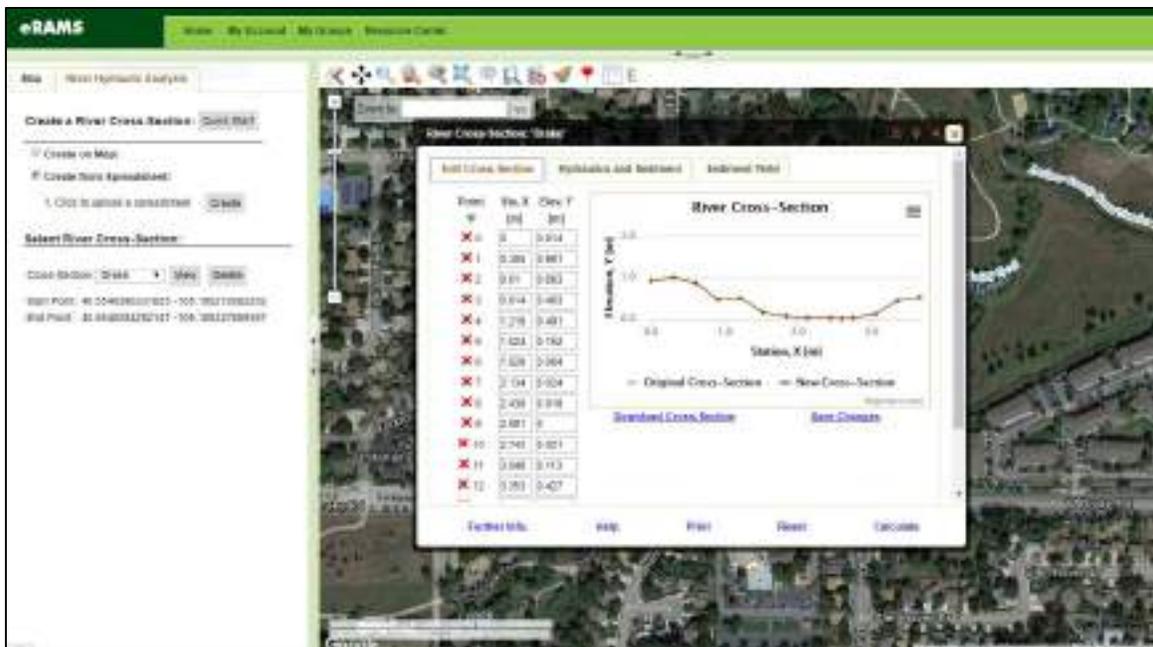
Figure 4: Example of the eRAMS Cross-Section Analysis tool

Figure 4 and Figure 5 provide examples of the cross-section analysis tool. It was necessary to survey the cross-section at each of the four monitoring locations in order to use the tool. Appendix B contains figures for each of the surveyed cross-sections at the four monitored locations. The area and hydraulic radius values were calculated based on the stream cross-section characteristics at the measured depths using the pressure transducer in the WaterTroll 9500 Sondes and Hobo U-20 Data Loggers. These characteristics were calculated by the cross-section analysis tool seen in Figure 5. A Manning's  $n$  value of 0.035 was assumed for the natural stream channel with some weeds and stones (Chaudhry 2008). The average slope was estimated for each site from surveying the thalweg points in the stream channel 25' above and 25' below the monitored location. The parameter values were assumed to be constant throughout sampling and are reported for each site in Appendix A.

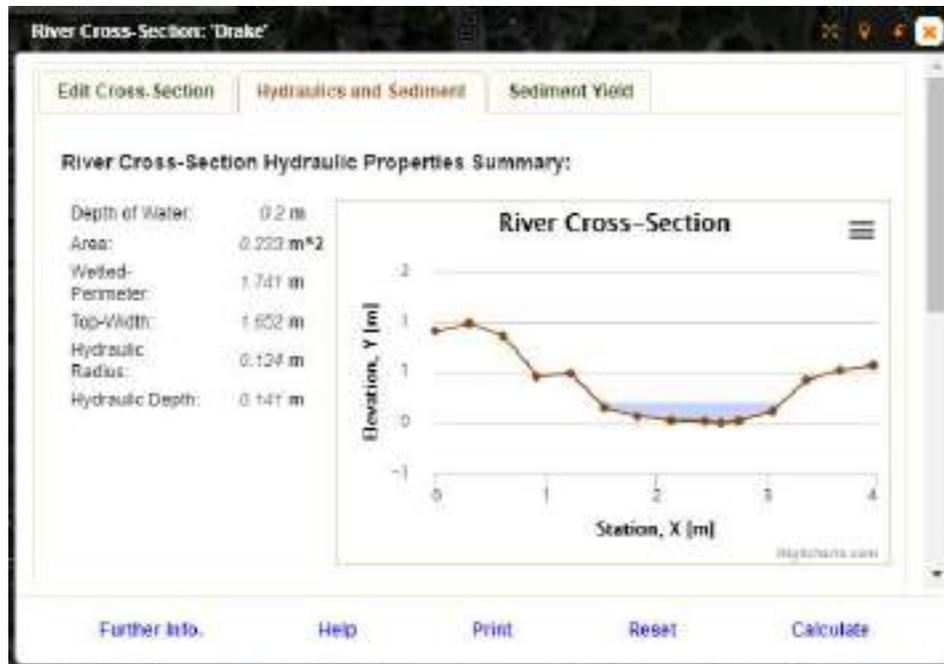
**Figure 5:** Example of the Cross-Section Analysis tool calculating the hydraulic radius based on depth

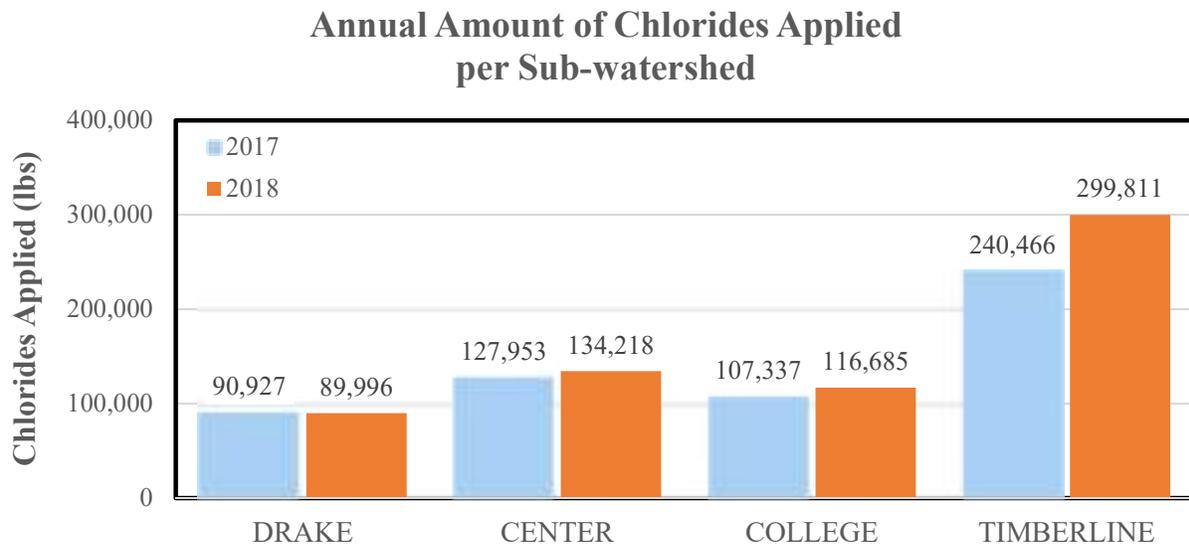
The amount of chlorides recorded as delivered was then compared to the amount of chlorides applied for RDO. Figure 6 displays the amount chlorides that were applied in both the 2016-2017 winter and the 2017-2018 winter. This plot demonstrates the amount of chloride applied in both seasons was roughly the same which creates some interesting implications. First, it could be that Fort Collins receives roughly the same types of storms each year requiring similar amounts of deicer. Alternatively, it could mean that the City expects to use a certain amount of deicer and ends up using that approximate amount regardless of the storms.

**Figure 6:** The amount of chlorides applied in the 2016-2017 winter and the amount applied in the 2017-2018 winter within each sewershed

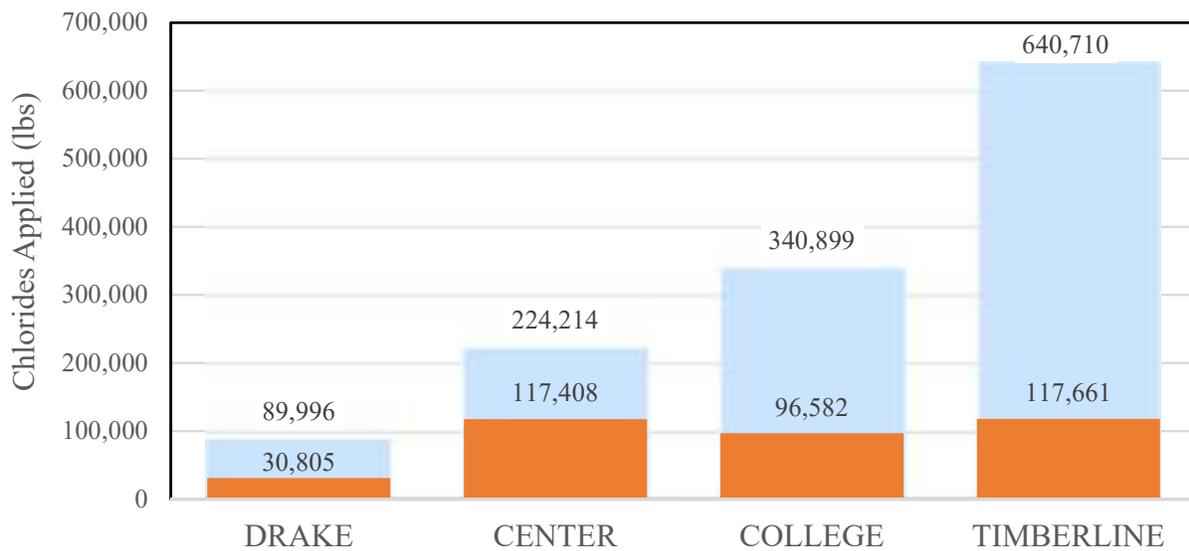
**Figure 7:** Chlorides applied for RDO compared to the amount of chlorides measured at each monitoring location

In each monitoring location the amount of applied chlorides did not match the amount of chlorides delivered to the watershed. This was especially true of the Timberline location which only recorded 18.3% of the total chlorides applied from deicer of RDO. One of the major questions that the study sought to answer included the fate of the chloride which was not delivered during the winter runoff event. Despite this lack of chloride delivery, a slight positive relationship between the amount of chlorides applied and the amount delivered was typically observed. This demonstrates that it should be possible to reduce the amount of chlorides that enter the Spring Creek by simply reducing the amount of chlorides applied. However, the weak correlation shown by low  $R^2$  values suggest that this may not be the most effective way to reduce chlorides in urban streams, but will still remove chlorides from other sources such as groundwater, which could be causing other long-term water quality problems as discussed below.

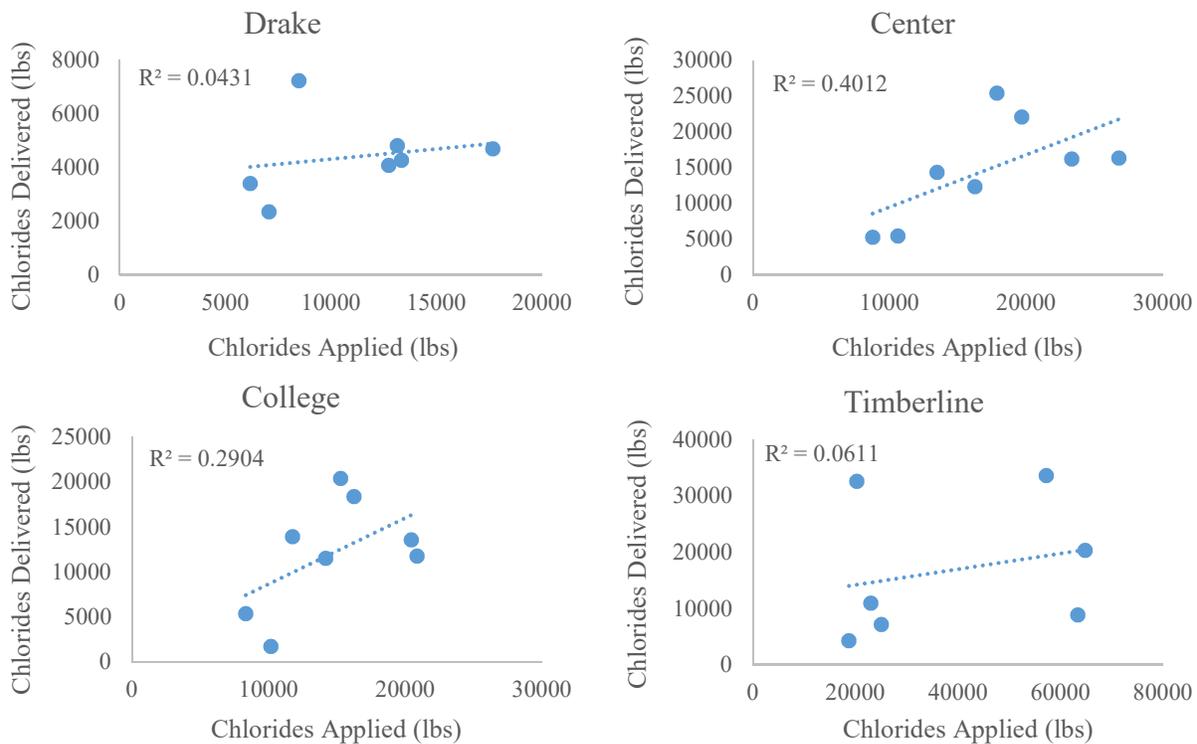
**Figure 8:** Comparison of the amount of chlorides applied and the amount of chlorides delivered. A positive relationship shows that more chlorides applied result in more chlorides delivered. The low R<sup>2</sup> value demonstrates that the correlation between the chlorides applied and delivered is not very strong.

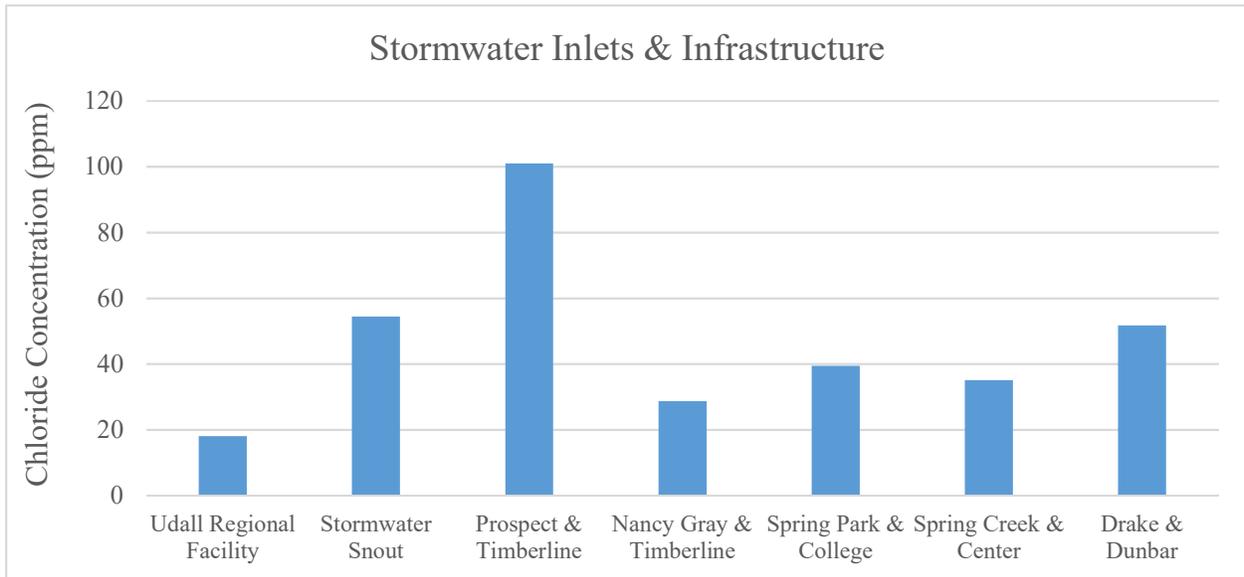
For this analysis, samples were collected from five different inlets as well as at two different stormwater control measures including a wetland basin and an inlet containing a stormwater snout. Figure 9 shows the chloride concentrations of the solids that were sampled. Based on the concentrations found from the lab analysis and the amount of storm sewer solids that are typically removed from all inlets, it was determined that this was not a significant fate of chlorides.

**Figure 9:** Results of the stormwater sewer solids analysis showing chloride content of the sampled solids

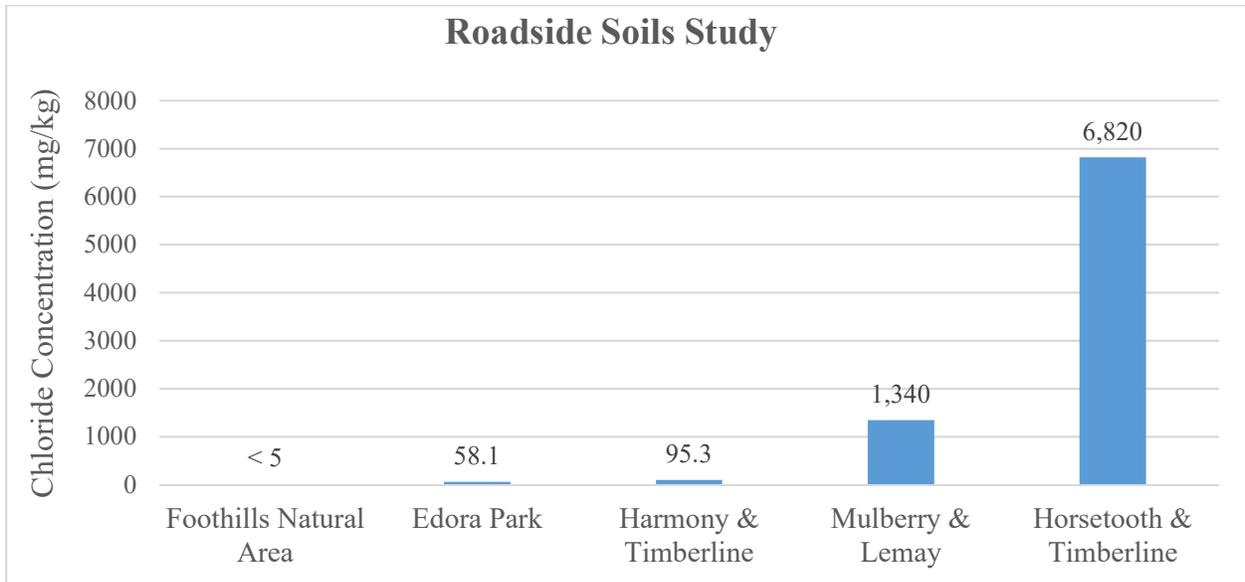
Results of this analysis (Figure 10) demonstrate high concentrations found in roadside solids, which can be considered a potential fate of chlorides and one explanation for the discrepancy between the applied and delivered chlorides. However, there was a large variation among roadside soils with some roadsides having small chloride concentrations and others having vary large concentrations. Some factors that could explain the variation of chloride concentrations include the presence of curbs, the speed of snowplows and the amount of deicer applied at that particular stretch of roadway.

**Figure 10:** Results of the analysis of chloride concentrations of roadside solids

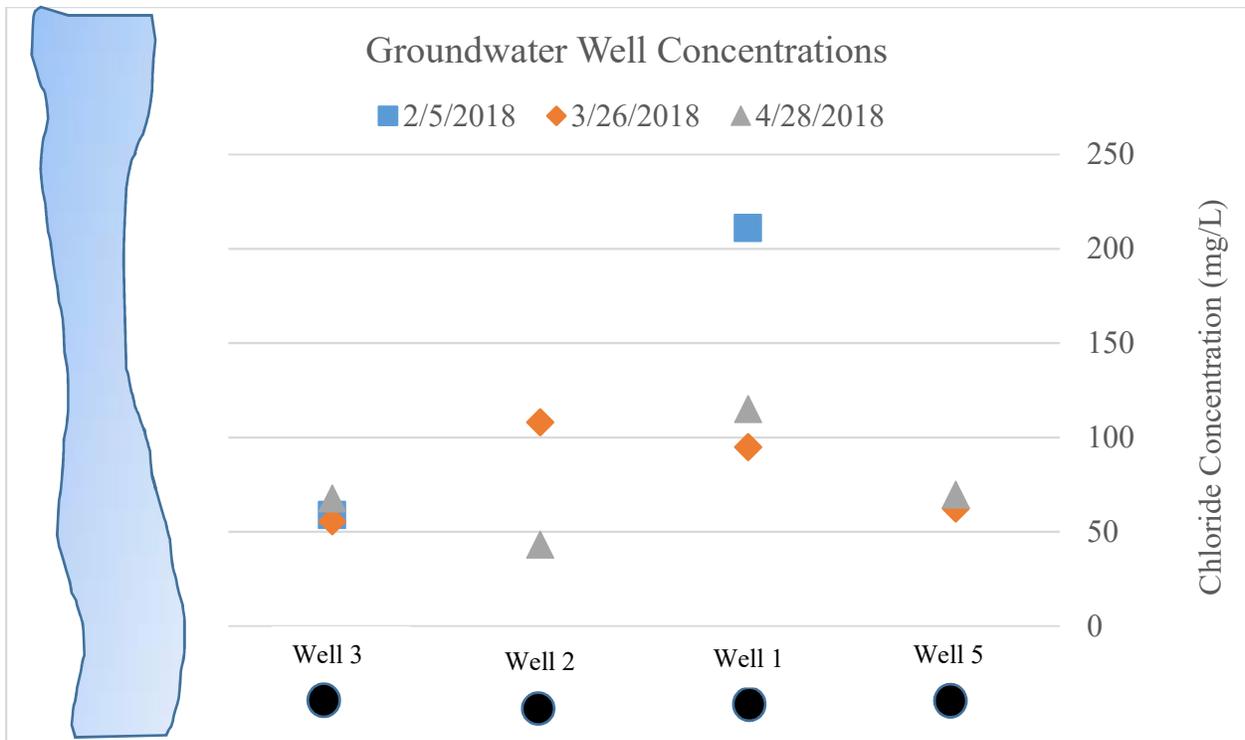
To investigate the interaction of the groundwater and surface water, four groundwater wells, 3, 2, 1 and 5 were located 15', 30', 50' and 70', respectively, away from Spring Creek, and were used to collect grab samples after winter runoff events to see if there were elevated levels of chlorides compared to the stream at the same time. Elevated chloride levels would establish that chloride was leaving the surface water and entering the groundwater system along the stream. Results from the groundwater analysis are shown in Figure 11. Figure 11 displays chloride concentrations in order of each groundwater well's geographical location compared to Spring Creek.

**Figure 11:** Chloride concentrations in groundwater after winter runoff events

The pulse that appears to be present after storms occur demonstrates the transport of chlorides between groundwater and surface water. Future analysis would include more detailed sampling of groundwater to accurately determine the timing of the pulse in order to quantify the magnitude of transfer taking place. It may be necessary to place a water quality sonde into the groundwater well to collect timeseries of the chloride concentration within the groundwater well.

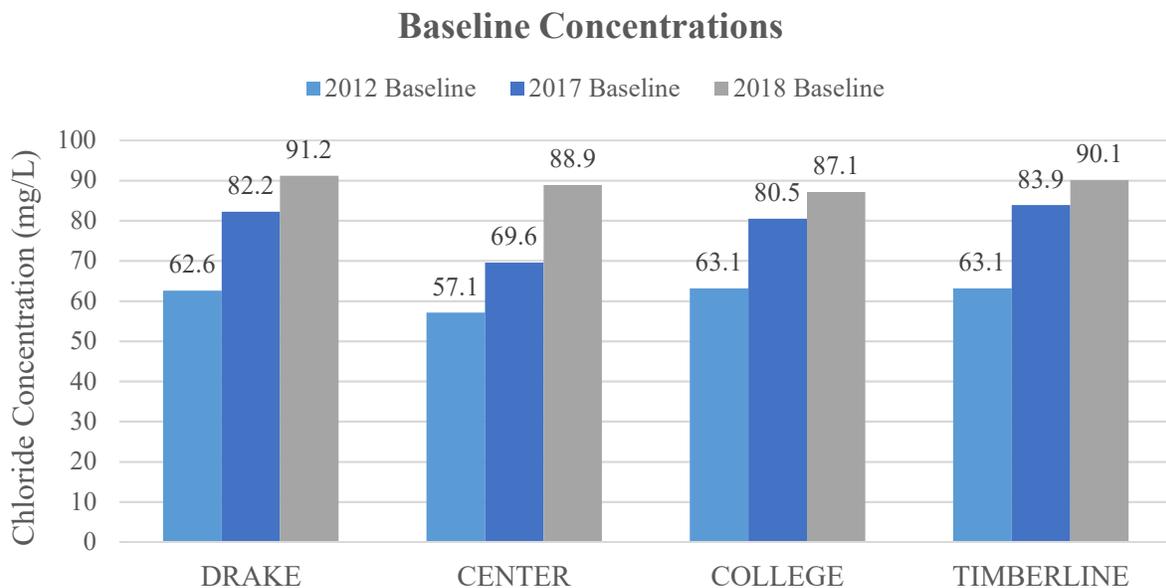
Baseline concentrations have been increasing overtime. The change in baseline conditions for the 2012, 2017, and 2018 winters are displayed in Figure 12. Assuming baseline chloride concentrations continue to rise at the observed rate, it would take the Drake, Center, College, and Timberline subwatersheds 13.3 years, 5.3 years, 6.7 years, and 22.2 years to reach the chronic toxicity level of 230 mg/L, a level set by the Colorado Department of Public Health and Environment for water to be used as a drinking water source.

**Figure 12:** Baseline Concentrations at each monitoring location based on the 2012, 2017 and 2018 winters

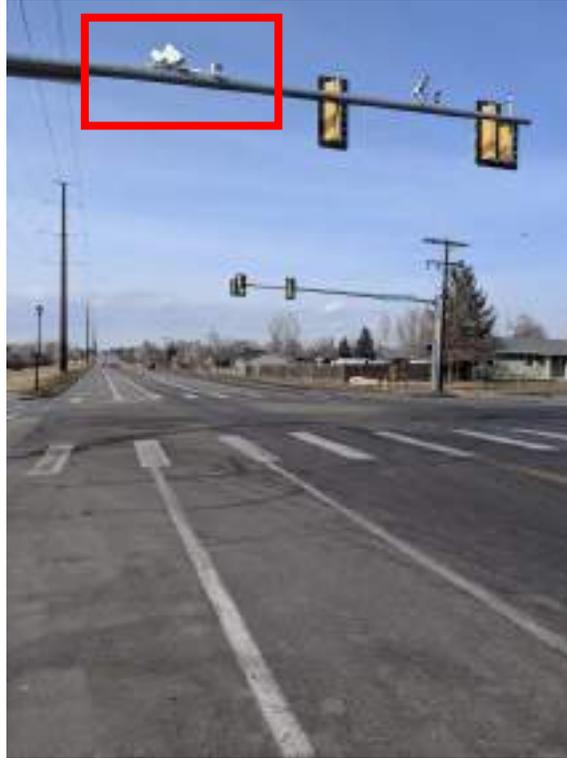
Data for pavement performance was provided by cameras and sensors that are placed at the roadway of intersections. These pavement performance sensors (PPS) provide several datasets including the level of grip, snow, ice and water accumulation, and pavement temperature. Many of these sensors also have weather monitoring equipment to provide localized weather information important for determining metrics about the storm severity such as humidity, air temperature, and wind speed. The map shown above in Figure 2 shows the locations of these PPSs in the Spring Creek watershed. Figure 13 shows a picture of one of the sensors at Overland and Prospect in Fort Collins, CO.

**Figure 13:** Pavement performance sensor recording performance for the southbound lane of Overland Trail just south of the intersection with Prospect in Fort Collins, CO.

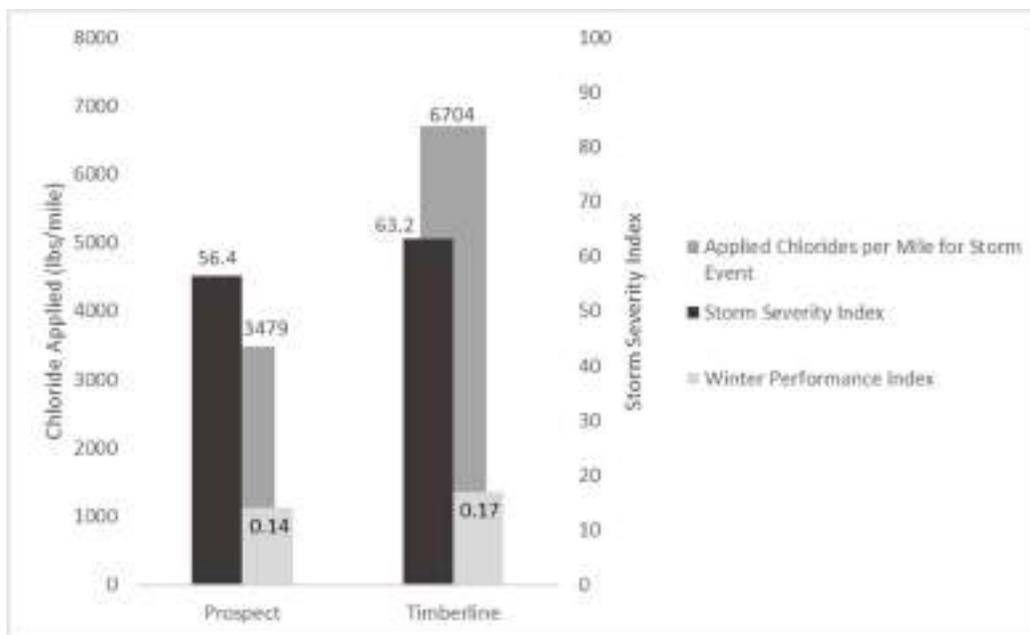
For two of the PPS, an analysis of the chlorides that were applied based on AVL data was conducted. The sensors that were considered included Prospect @ BRT and Timberline – Nancy Gray. The SSI rating for the storm at the Prospect pavement sensor was found to be 56.4, and 63.2 for the Timberline pavement sensor. The WPI index value for the Prospect pavement sensor was found to be 0.14, and 0.17 for the Timberline pavement sensor. During this storm event 134,581lbs of chloride were applied to the roadway in the Spring Creek Watershed. For the Prospect @ BRT sensor 2,783lbs of chloride were applied for 0.8 miles of roadway, and 6,704lbs were applied on Timberline – Nancy Gray for 1 mile of roadway. The total application of chloride for 1 mile of roadway for Timberline Road was found to be 6,704 lbs/mile, and 3,479 lbs/miles at Prospect. Figure 15 shows the combination of all three metrics for the two sensors.

**Figure 15:** Application Rate, Storm Severity Index, and Performance for Prospect and Timberline

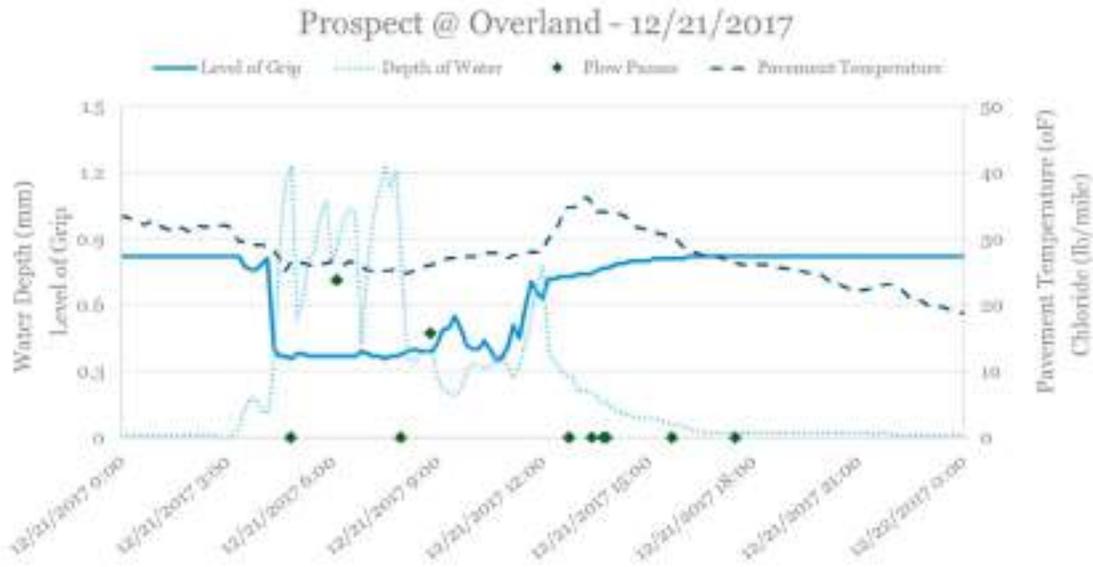
**Figure 16:** Roadway performance at Prospect and Overland for the 12/21/2017 winter event

Each figure demonstrates that there are a number of factors that dictate roadway performance, particularly the recovery of the level of grip. One of the surprising factors was that there was not always an immediate response to passes on the plow. This is evident in Figure 16 where a plow delivered a large application of deicer, but there was no measured effect on the level of grip. Figure 17 shows an example of two passes that were done by snowplows where one of them had a minimal effect and another had a substantial effect. Also seen in Figure 17, there appeared to be additional influences causing fluctuations in level of grip to both decrease and increase, which brings the accuracy of AVL data into question and suggests there are times when a plow is making a pass that is not being recorded.

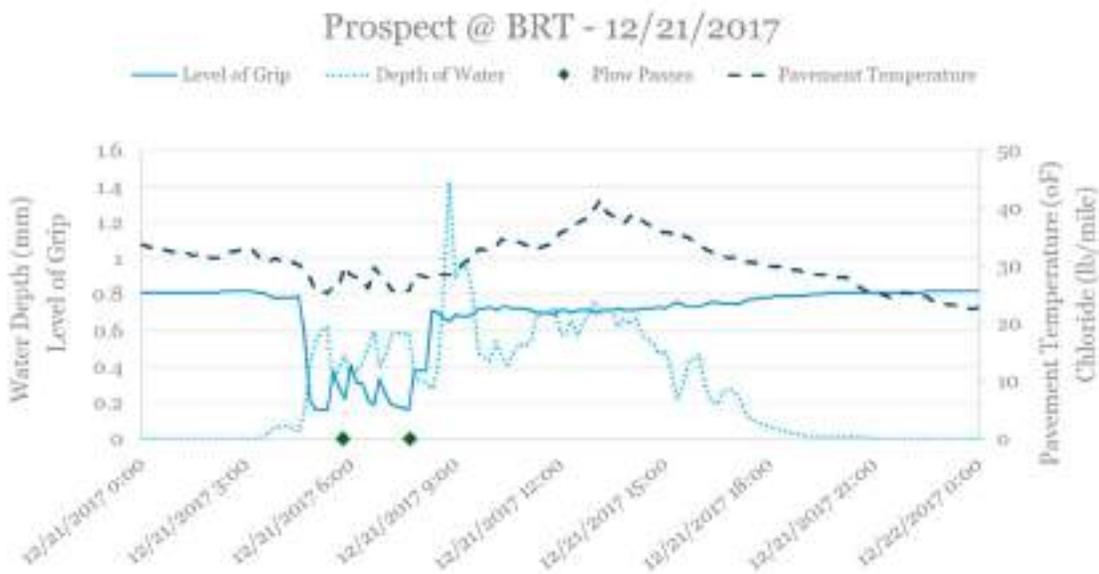
**Figure 17:** Roadway performance at Prospect and BRT for the 12/21/2017 winter event

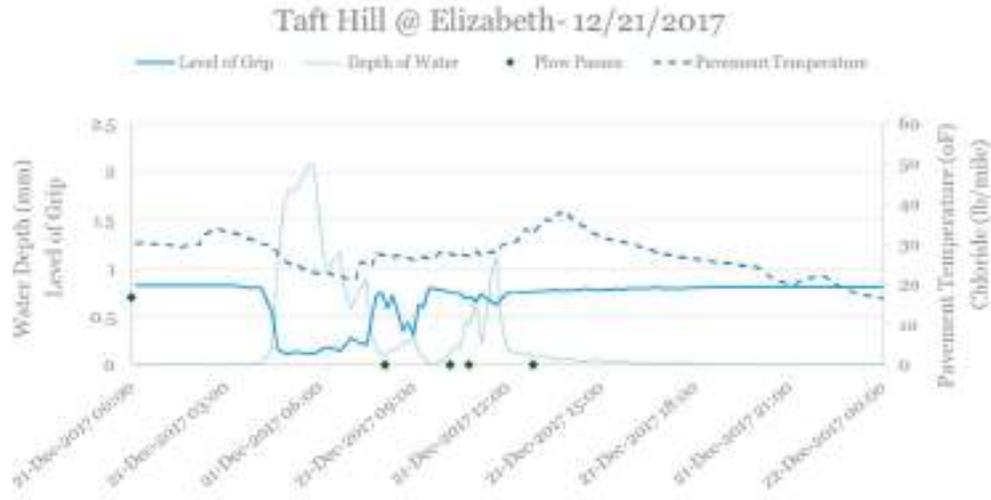
Figure 18 shows an example of anti-icing operations, the practice of applying deicing agents before the storm occurs. It appeared in this circumstance that anti-icing provided a significant benefit to the effectiveness of the first snowplow. However, with anti-icing it is important to note that it can only be used when there will not be any rain before the snow event or else the ant-icing agents are washed off rendering them ineffective.

**Figure 18:** Roadway performance at Taft Hill and Elizabeth for the 12/21/2017 winter event

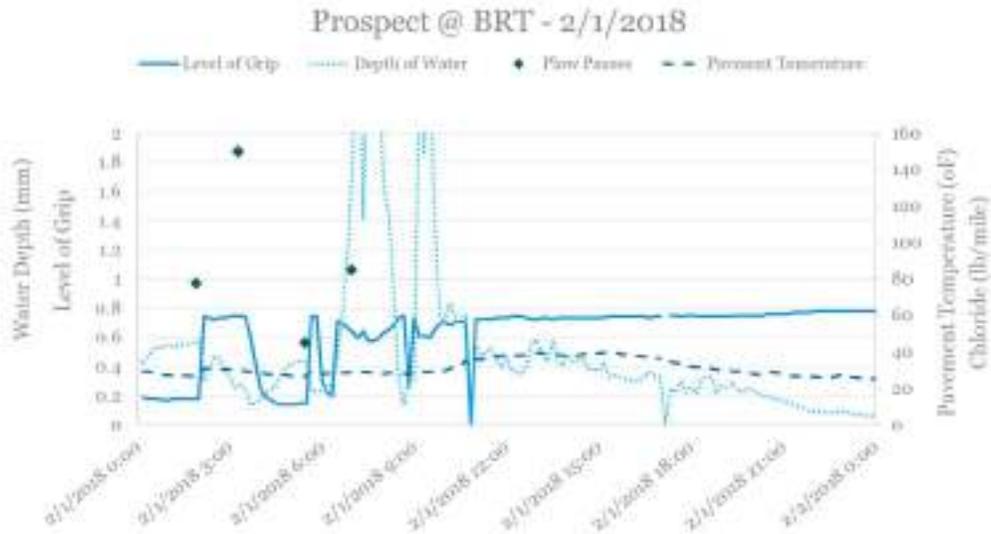
Figure 19, shows the variation of performance of deicing operations. In some circumstances the deicing agent and plow pass had a substantial improvement, but at other times it did not. This demonstrates that there are additional factors that should be considered when wanting to optimize the performance of RDO. Finally, Figure 20 shows that large amounts of deicing application may not necessarily result in immediate performance improvement. This indicates that there may be times when deicing should not be applied because it will not have any effect on roadway performance.

**Figure 19:** Roadway performance at Prospect and BRT for the 2/1/2018 winter event

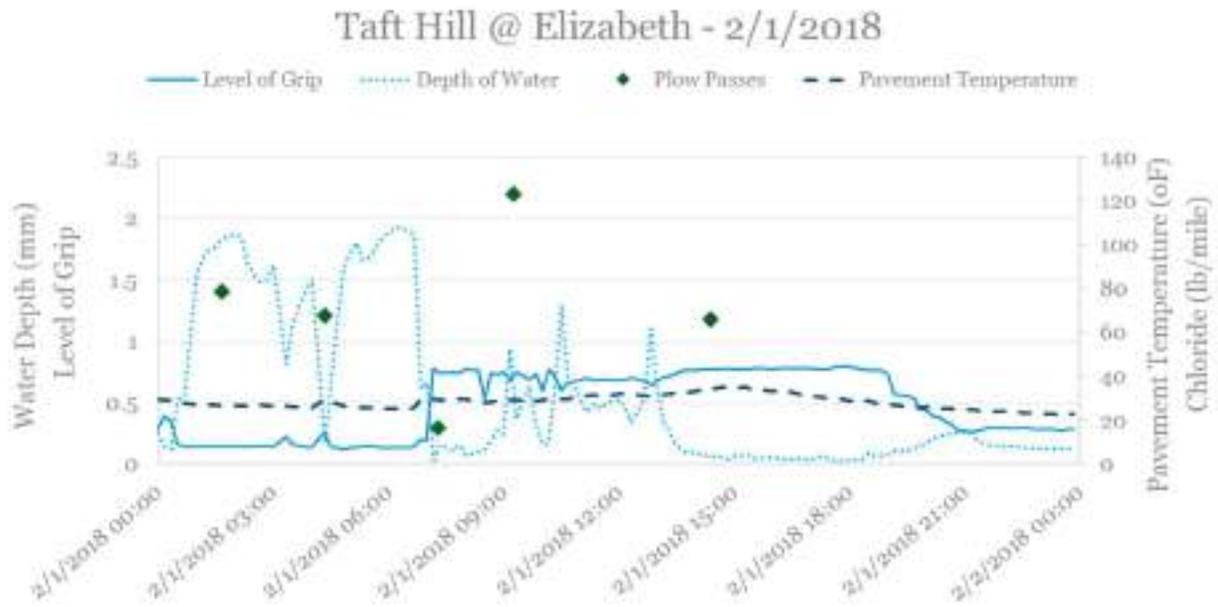
**Figure 20:** Roadway performance at Taft Hill and Elizabeth for the 2/1/2018 winter event

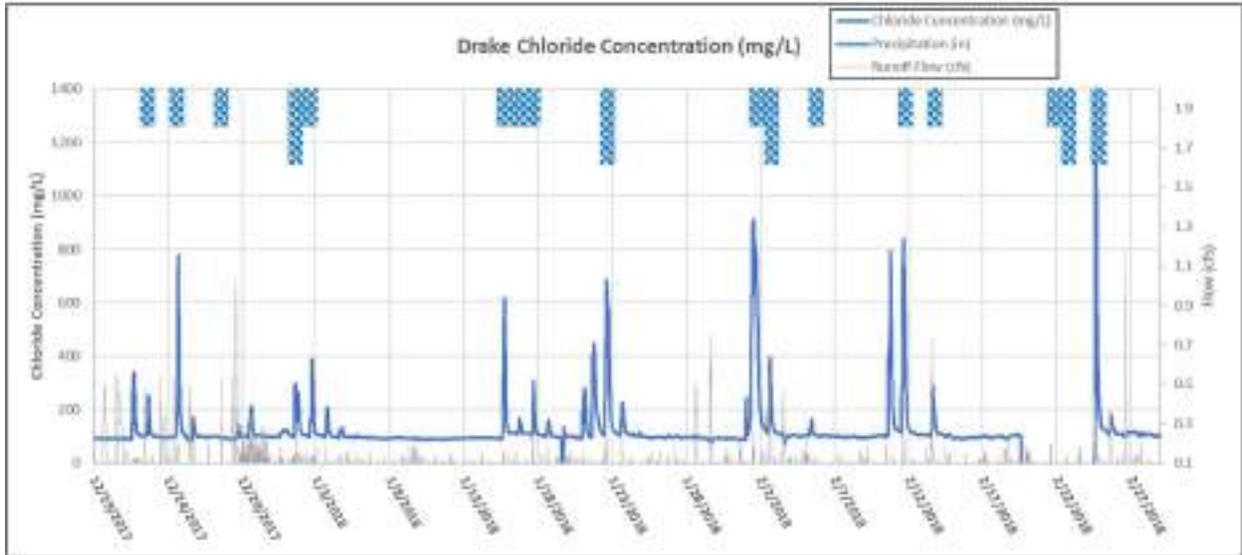
Figure A.1: Chloride concentrations at the Drake monitoring station

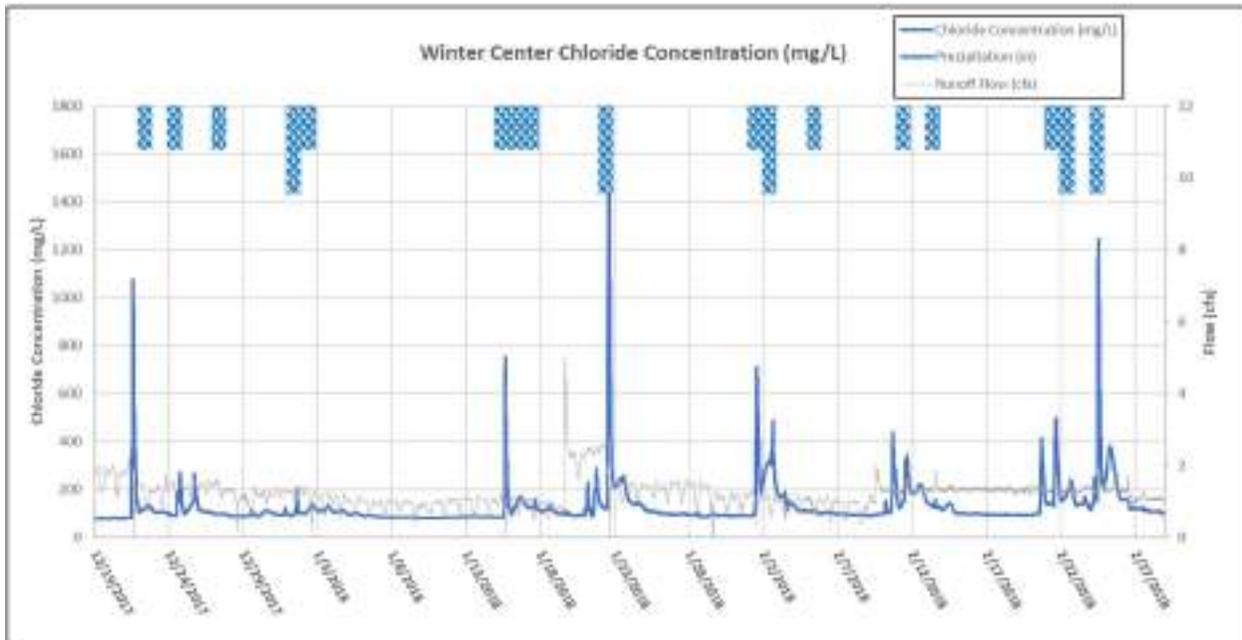
Figure A.2: Chloride concentrations at the Center monitoring station

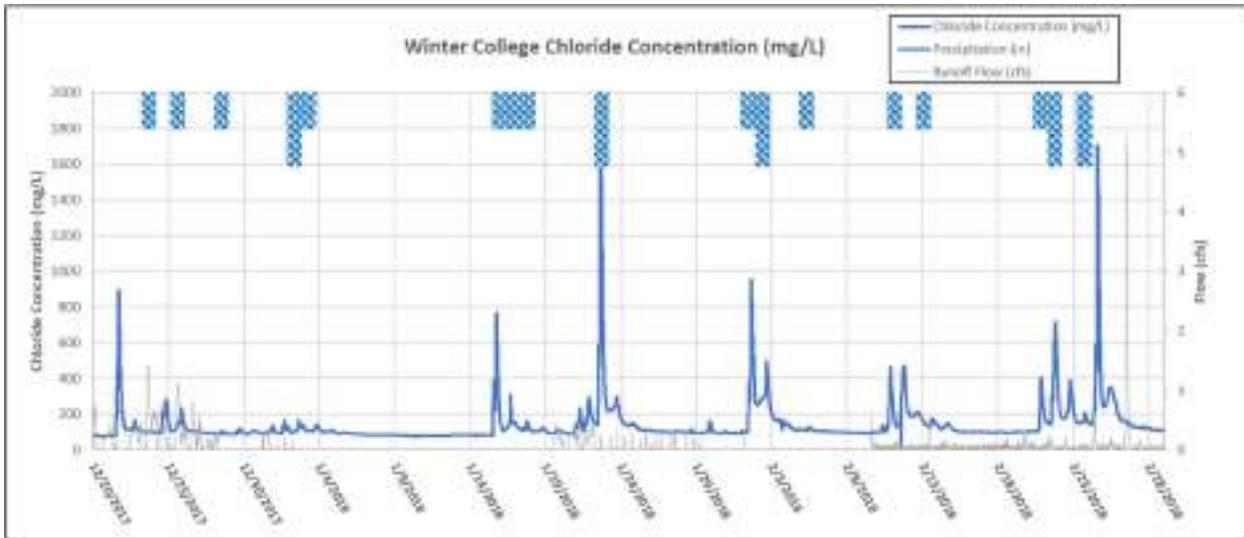
Figure A.3: Chloride concentrations at the College monitoring station

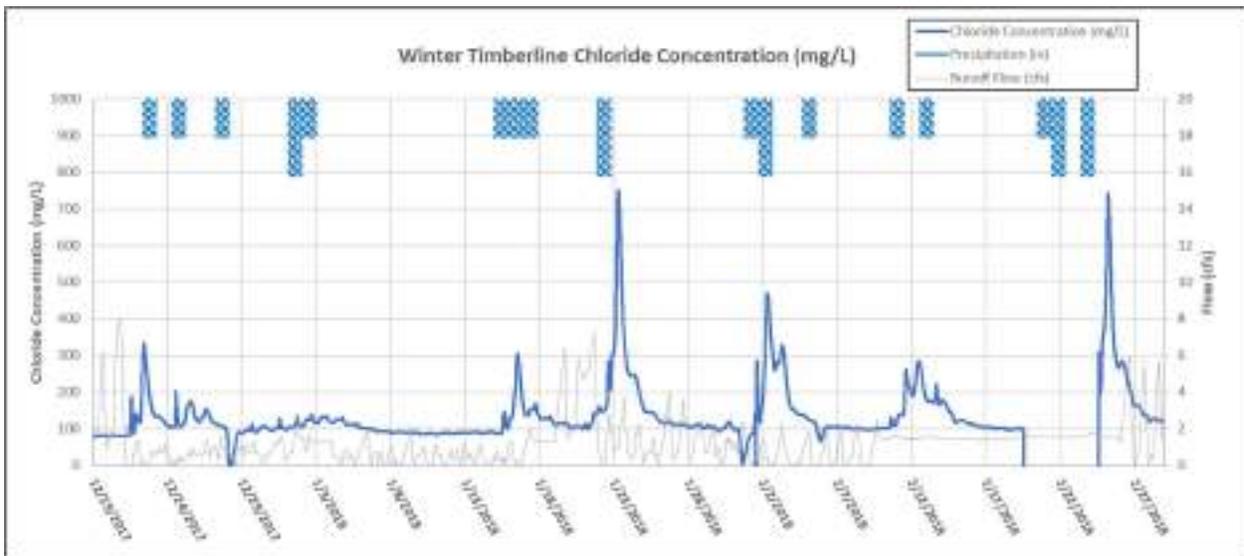
Figure A.4: Chloride concentrations at the Timberline monitoring station

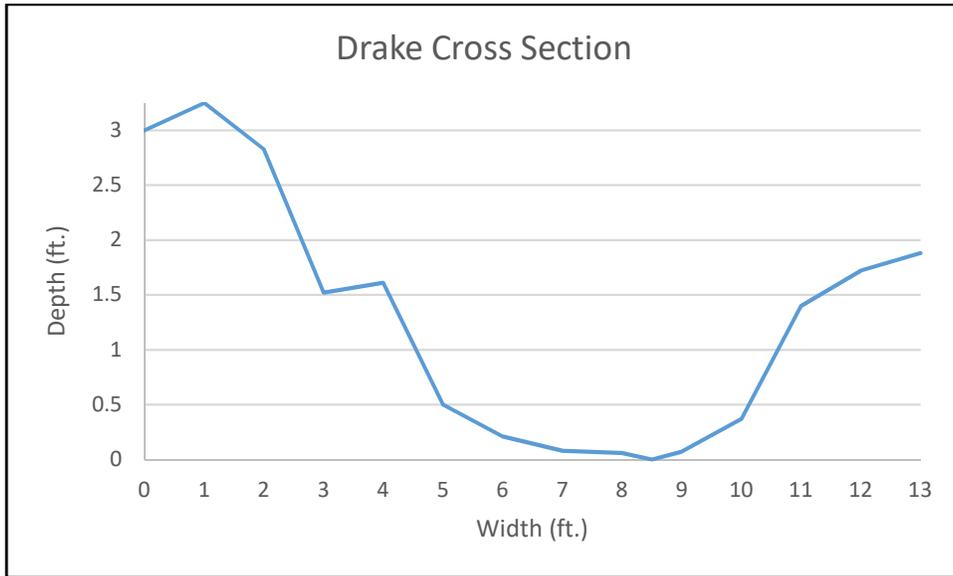
**Figure B.1: Cross-section at the Drake monitoring site**
