# Roadway Deicing Operations in the City of Fort Collins and Impacts to an Urban Stream

Department of Civil  
and Environmental  
Engineering

*March 10, 2021*

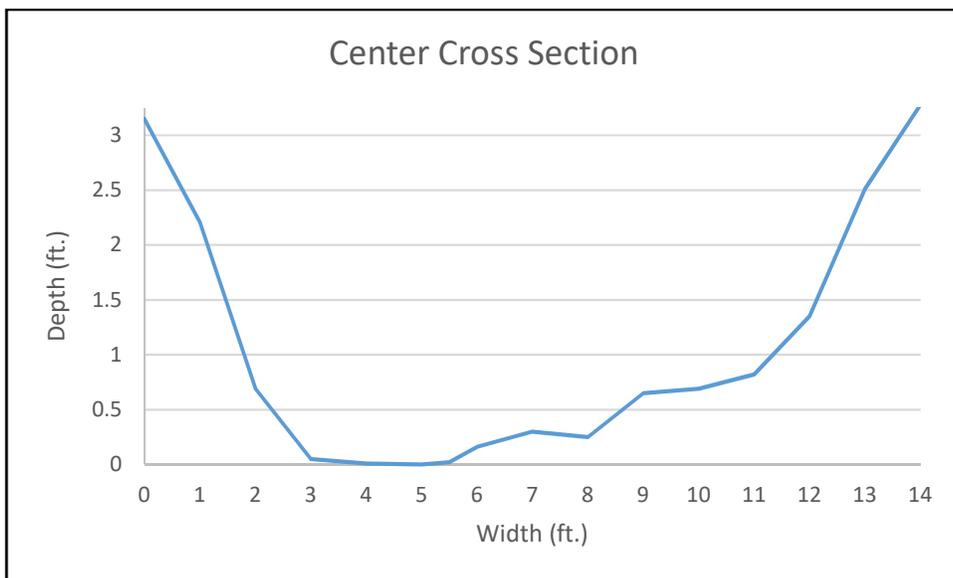
**Figure B.2: Cross-section at the Center monitoring site**

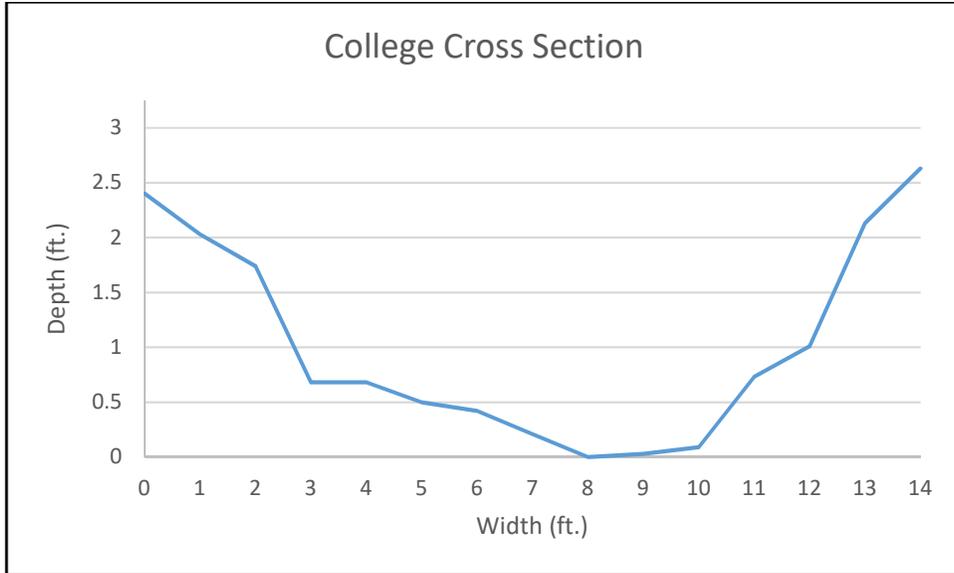
**Figure B.3: Cross-section at the College site**

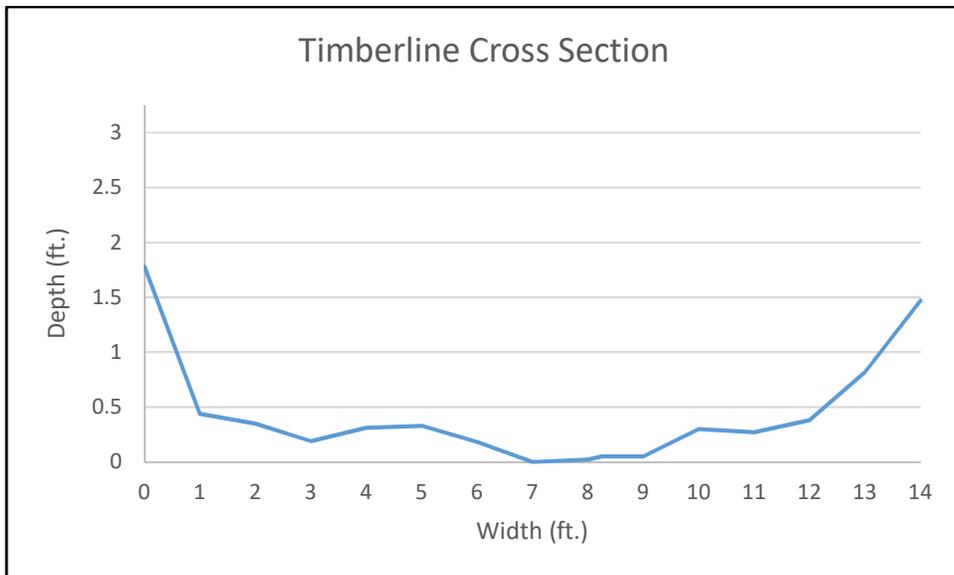
**Figure B.4: Cross-section at the Timberline site**

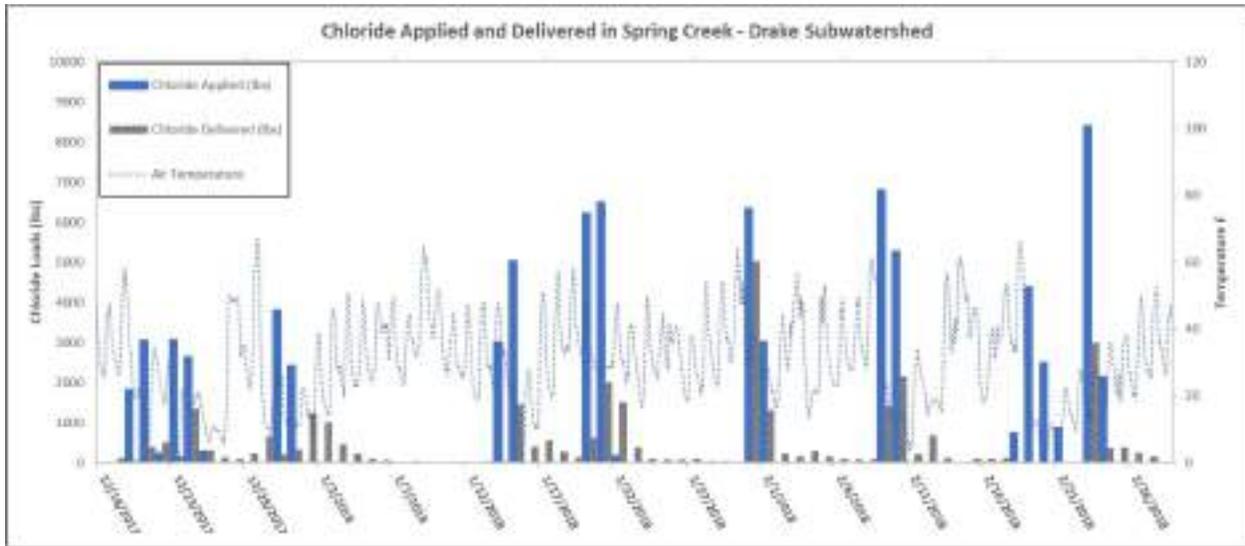
Figure C.1: Mass of chloride applied and delivered for the Drake subwatershed and monitoring location

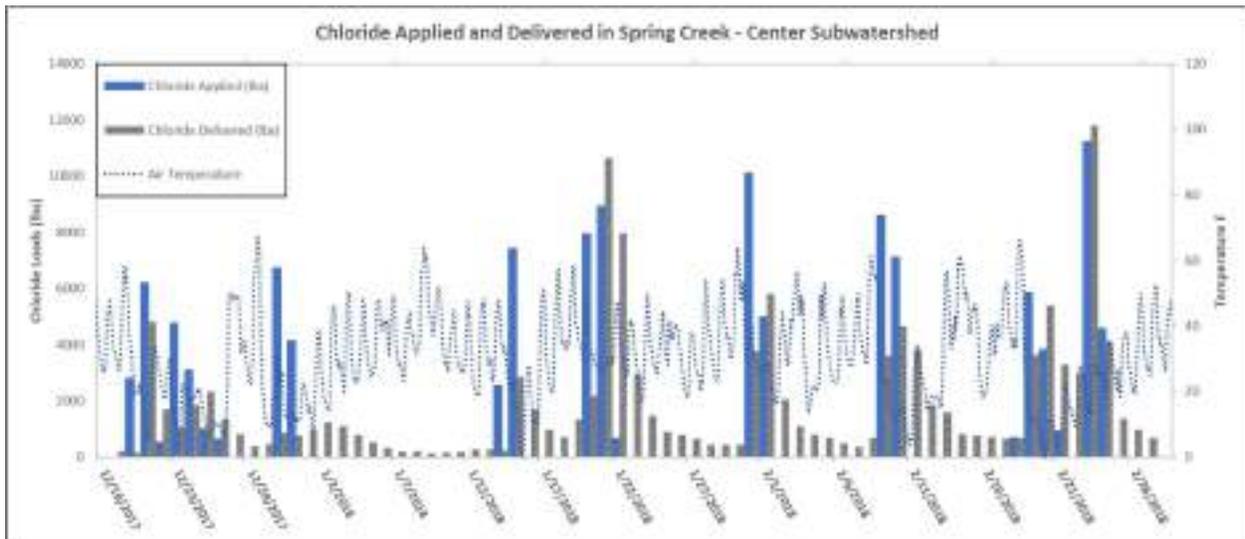
Figure C.2: Mass of chloride applied and delivered for the Center subwatershed and monitoring location

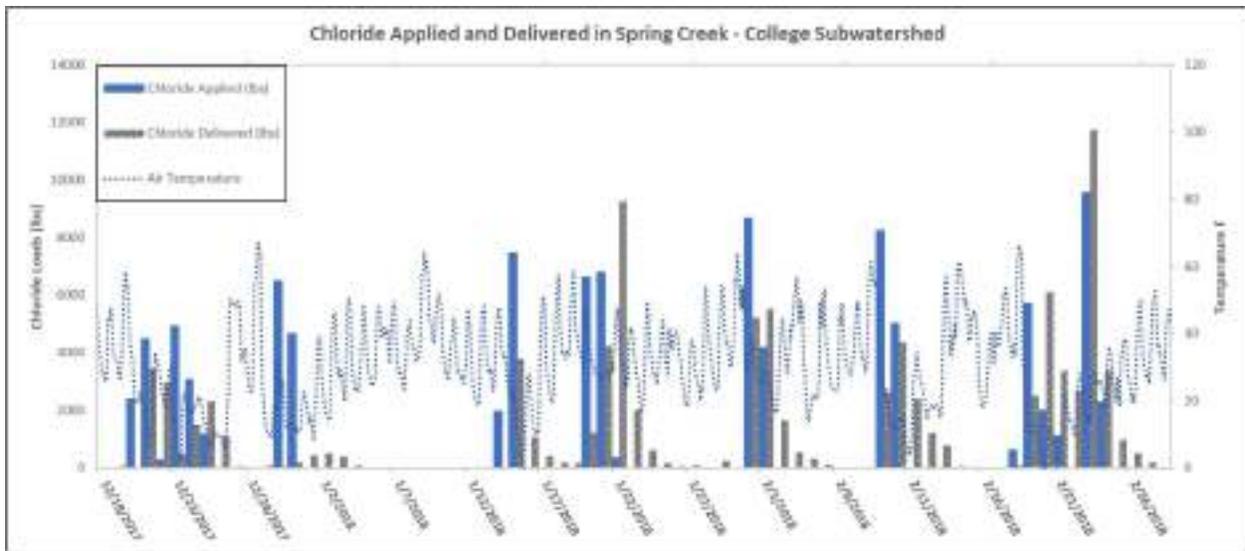
Figure C.3: Mass of chloride applied and delivered for the College subwatershed and monitoring location

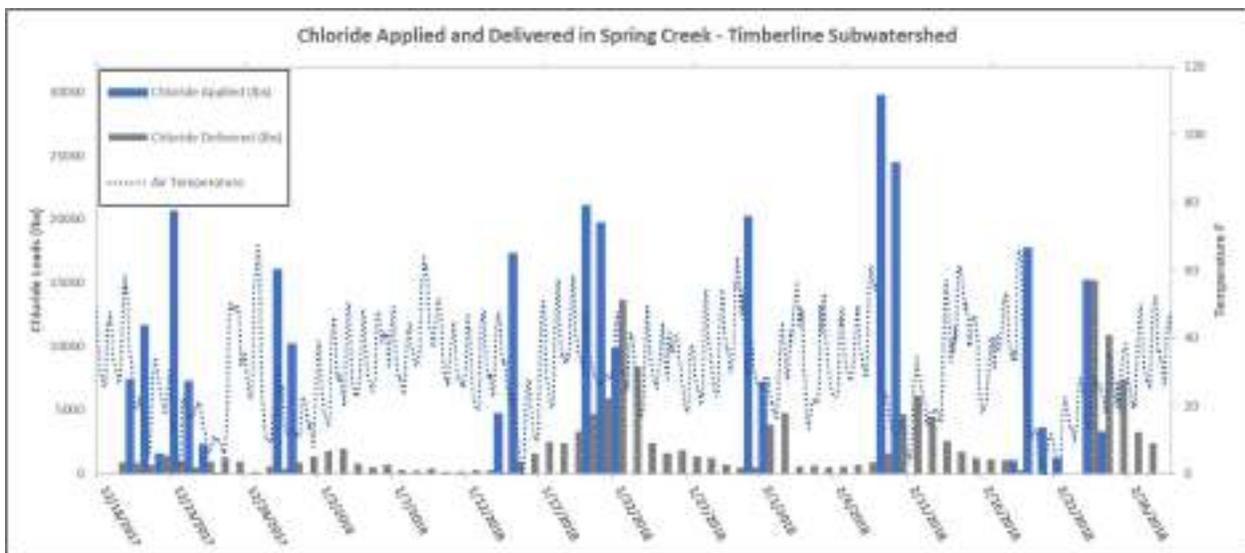
Figure C.4: Mass of chloride applied and delivered for the Timberline subwatershed and monitoring location
